## Confidential Inspection Report

James D'Angelo  
Hometech Property Inspections

**Client:** Client.  
**Inspection Site:** Park City, UT.  
**House Occupied?** No.  
**People Present:** Purchaser.

**Main Entry Faces:** North.  
**Estimated Age:** 30.  
**Building Type:** 1 family, Ranch.  
**Stories:** 1.  
**Space Below Grade:** Crawl space.

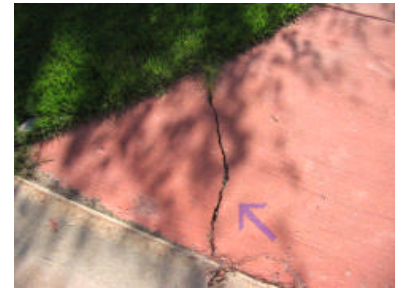
**Driveway:**

⋮ Ⓟ ⋮ Cracks noted are slightly more than typical but do not seem to pose any immediate problems.

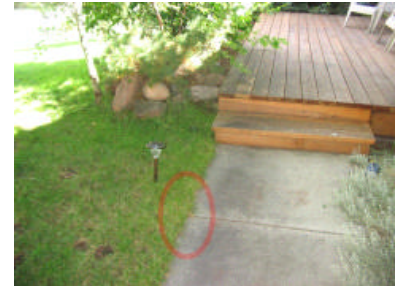
**Walks:**

Ⓟ ⋮ ⋮ Sidewalk type: Concrete, slight sloping towards front yard.

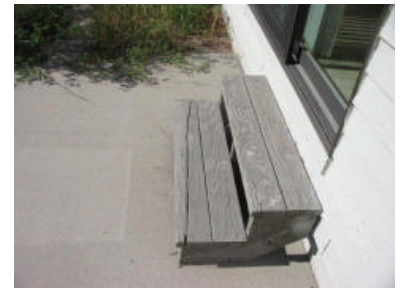
**Exterior Steps / Stoops:**

⋮ Ⓟ ⋮ The wood steps on the rear of home have some damage and are in need of minor repairs to make them sturdy.

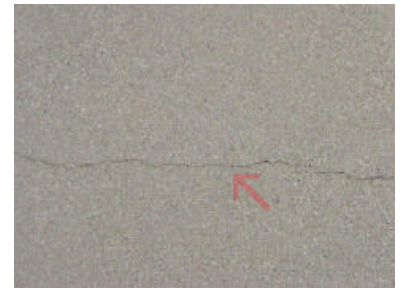
**Slab:**

Ⓟ ⋮ ⋮ Patio type: Concrete, Cracks noted - typical, back of house.

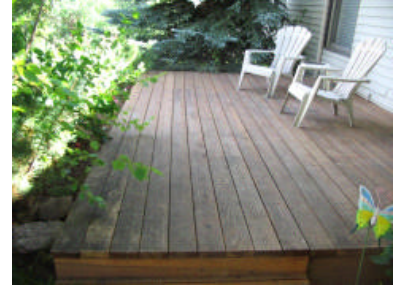
**Decks / Balcony:**

Wood. There are no railings on this deck, it is low to the ground so it doesn't appear to be a major safety hazard. This may not adhere to local code.

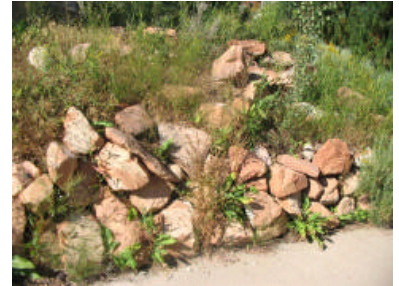
**Retaining Walls:**

Retaining wall type: Stacked rock. There is some damage to the walls that may worsen over time if repairs are not made.

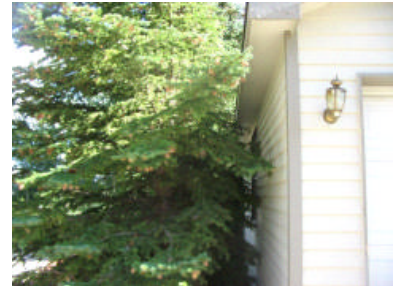
**Landscaping:**

Trim plants away from structure, Trees planted close to structure. Removal may be needed. Over time the large trees in front of the home will continue to grow. Trees should not touch home and may cause damage if they do. There were no current problems noted.

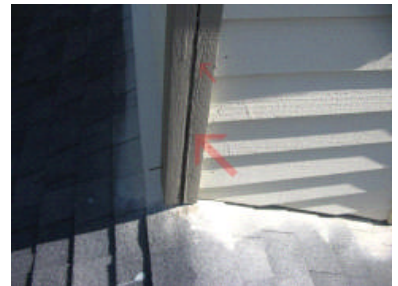
**Chimney Exterior:**    "    p    "    Minor trim damage noted.

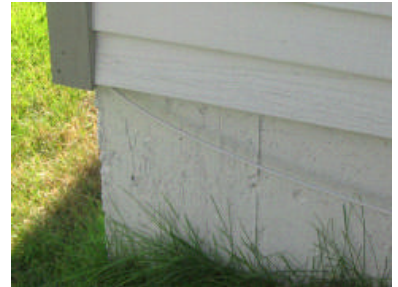
**Materials & Condition:** p " " Poured in place slab concrete, 8 inches or more thick. Typical cracks are noted.

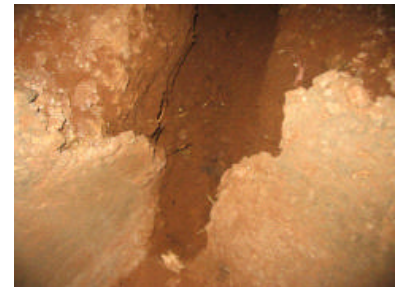
**Floor:**

Ⓟ    "    "    Soil. The water heater is set in an area lined with concrete with a drainage canal to compensate for any leaks or dripping. This canal was slightly moist at time of inspection and it doesn't lead to the exterior of the home, any moisture will be dispersed in the crawlspace and evaporate. This does not seem to pose a major problem, but may lead to higher than desired moisture levels from time to time.

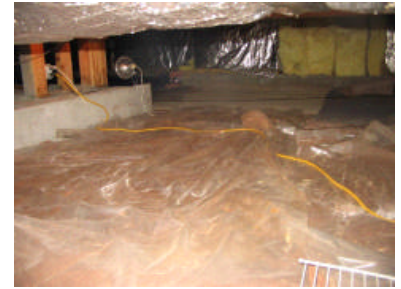
**In Unfinished Areas:**

There is a vapor barrier installed in most areas of the crawlspace floor it is a good idea to have the entire floor covered with this material..

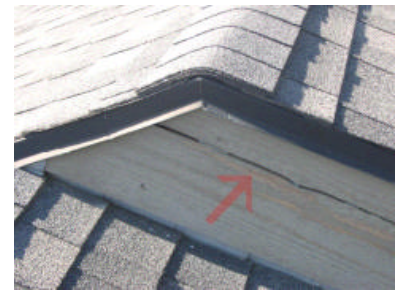
## Eaves - Soffits - Fascias:

" p " Some cracking noted to an area of the fascia on the roof, near the garage. This should be repaired to prevent further damage and water intrusion.

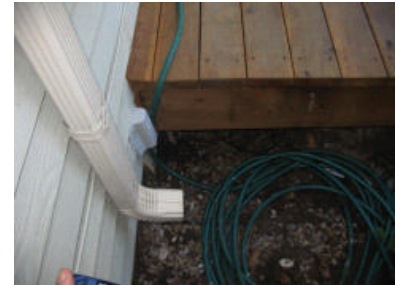
## Gutters & Downspouts:

" p " Route downspouts away from the building, water appears to pool and may run towards foundation. You can add an extension and route the water towards the front yard so it drains away from the home.

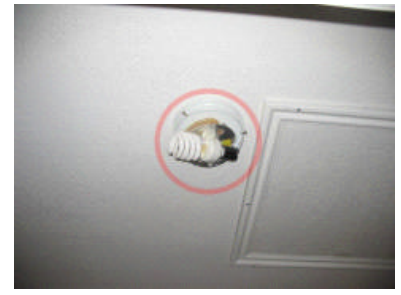
**Master Bedroom:**

Light cover missing in the closet.

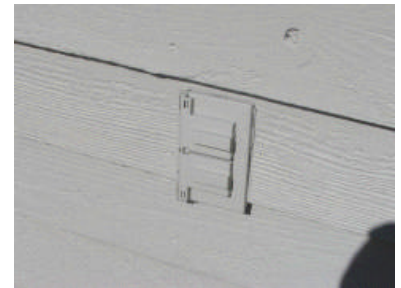
**Exterior Walls:**

Outlets did not function at time of inspection.  
Repairs needed.

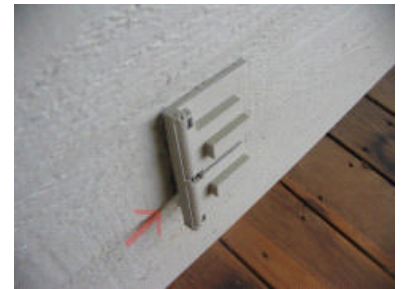
Outlet on front porch was loose.

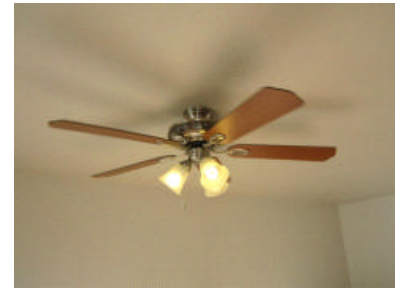
**Bedroom #2:** The ceiling fan installed in this room did not function using normal controls. Repairs are needed.

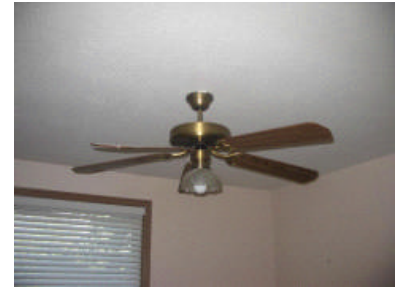
**Bedroom #3:** The ceiling fan installed in this room appears to need some adjustment. The fan blades wobble. Apparently the blades need to be balanced.

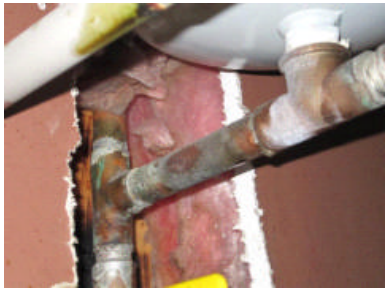
**Condition:** p " " Minor corrosion is noted.

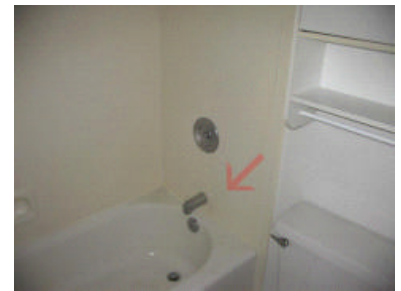
**Master Bath:**        "    "    p    There is low water pressure at this fixture, in its current condition the shower head does not work properly.

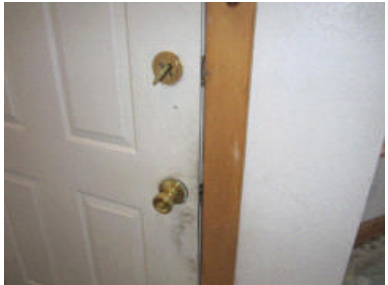
**Main Entry Door:**      ..    p    ..    Damage viewed.

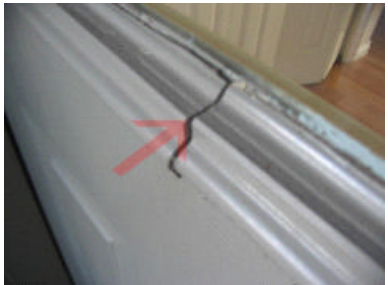
**Entry / Foyer / Hall:**      Damage viewed to the exterior glass trim, this may result in moisture intrusion and damage to the door over time.

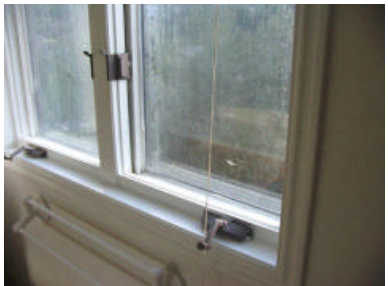
**Master Bath:**              At least one window or associated hardware in this room needs repair. Locking hardware needs repair or replacement, The thermal seal is broken. Although it is keeping the elements out, it has a clouded appearance. This condition will worsen.

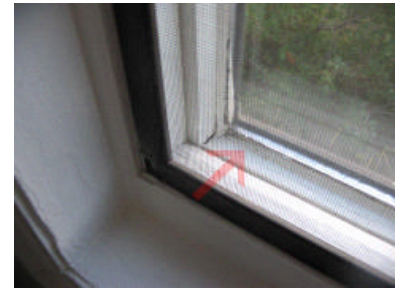
**Other Bath:**

Damage noted to the wood part of window.

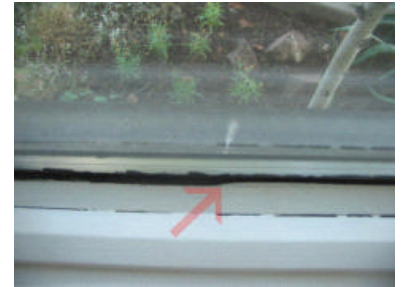
**Living Room:**

Deterioration to the inner seal, these windows are still sufficiently keeping the elements out but there life may be limited.

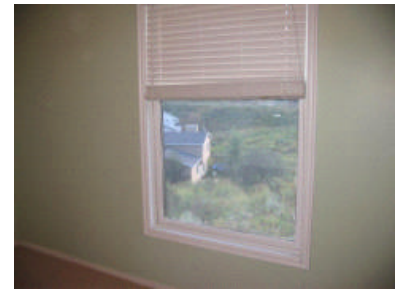
**Master Bedroom:**

At least one window or associated hardware in this room needs repair. Window will not open and the inner seals have damage noted.

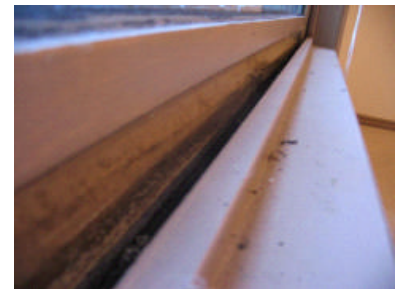
**Bedroom #3:**

Moisture damage noted on the bottom and the wood is warped. This is in need of repair before more damage occurs.

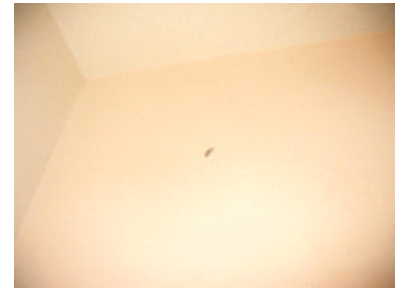
**Hall Bath:**

There is some minor cracking in the sheetrock. Most likely this is due to slight settlement or shrinkage.

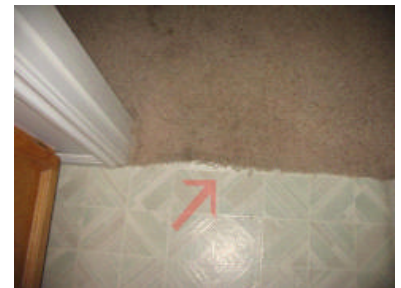
**Master Bath:**

The floor covering material is vinyl. A carpet strip needs to be installed to separate the vinyl from the carpet and prevent future damage to the carpet.

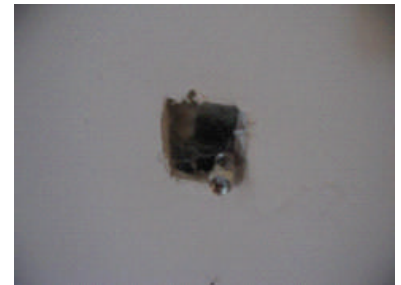
Cover plate missing.

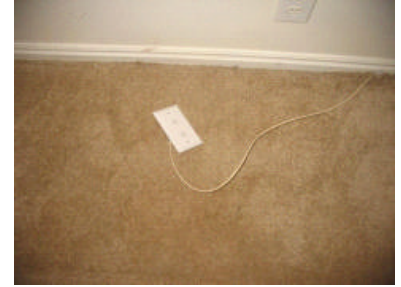
**Bedroom #2:**

There is a telephone jack installed in this room. It may or may not be functional. Not properly installed, dangling.

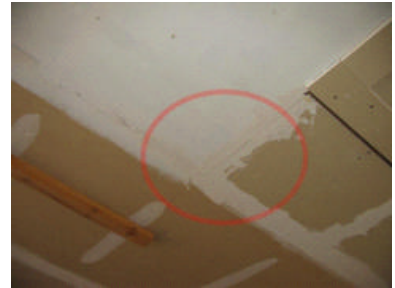
There are signs of past drywall repairs, this may have been from a past moisture problem. It was dry at time of inspection.

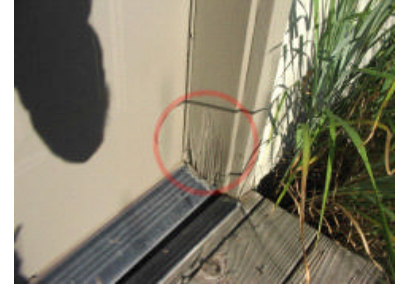
Damage viewed to the exterior jamb, minor repairs or paint may be needed. I was unable to open this door due to the fact that an old swamp cooler was in the way.

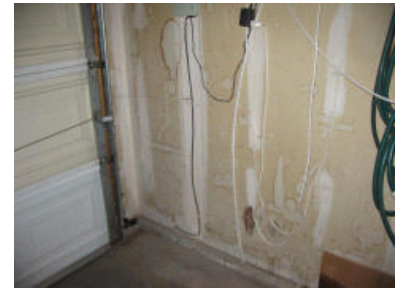
Drywall, Stains noted. These do not appear to be from a current problem.

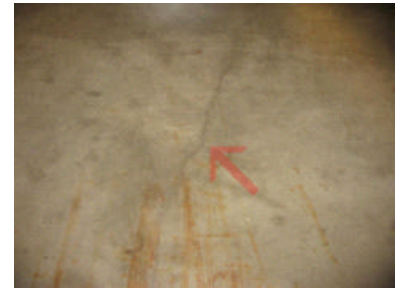
Typical cracks noted.
