## Confidential Inspection Report

James D'Angelo  
Hometech Property Inspections

**Client:** Client.  
**Inspection Site:** Park City, UT.  
**House Occupied?** No.  
**People Present:** Purchaser.

**Main Entry Faces:** North.  
**Estimated Age:** 30.  
**Building Type:** 1 family, Ranch.  
**Stories:** 1.  
**Space Below Grade:** Crawl space.

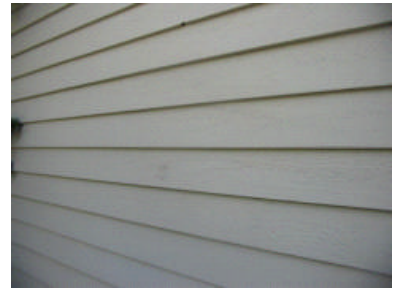
**Materials & Condition:** p    "    "    Walls are constructed with: Wood siding, paint appeared to be in newer condition.

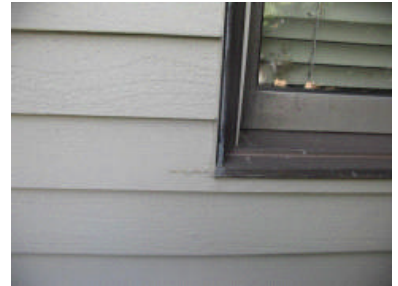
**Flashing & Trim:** p    "    "    Metal materials.

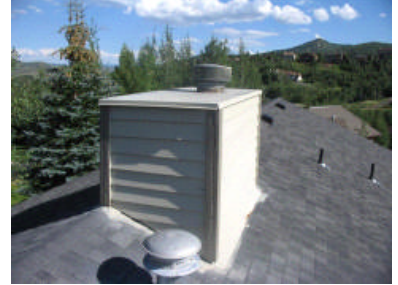
**Chimney Cap:** p " " There is a chimney cap.

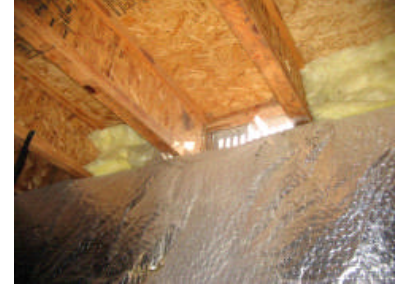
Ⓟ    "    "    Walls are poured concrete, insulated.

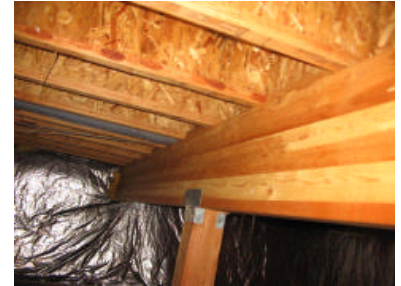
Ⓟ    "    "    Satisfactory - The main beam installed appears to be in satisfactory condition.

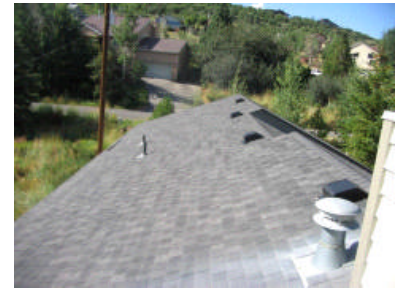
Gable.

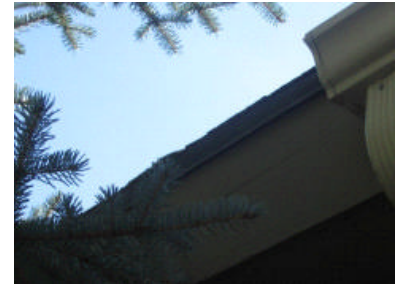
Ⓟ Ⓟ Ⓟ Metal.

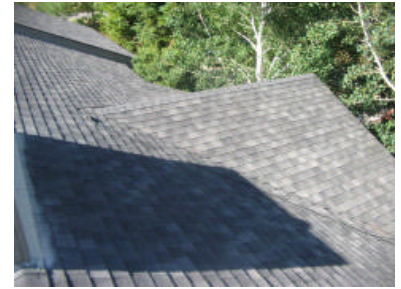
p " " Satisfactory - The valleys appear to be in satisfactory condition.

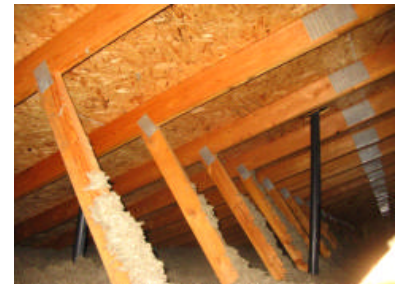
**Structure:** p " " A truss system is installed in the attic cavity that is used to support the roof decking and transmit the roof load to the exterior walls. The rafters or truss system appears to be in satisfactory condition.

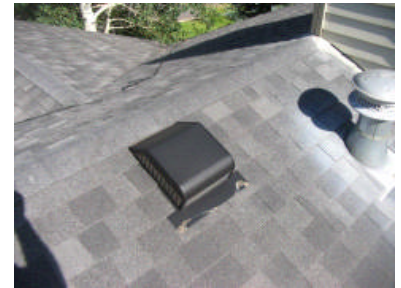
**Ventilation:** p " " Ridge vents installed.

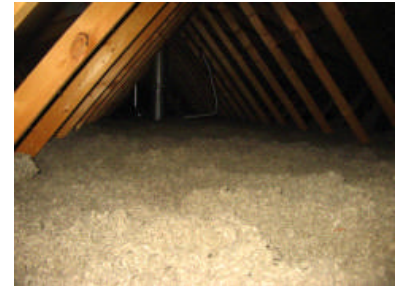
**Insulation:** p " " Fiberglass- Blown.

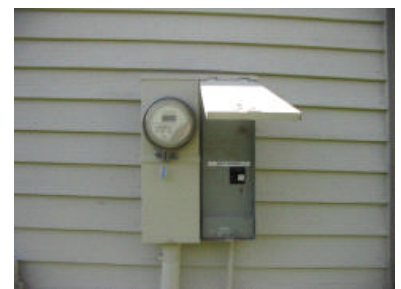
**Type & Condition:** p " " 110/220 Volt, Circuit breakers.

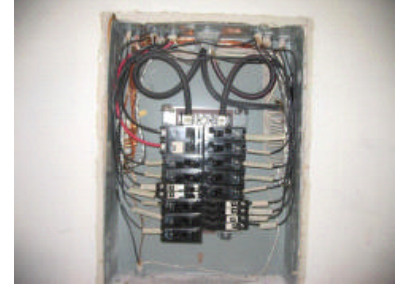
Circuit and wire sizing correct so far as visible.

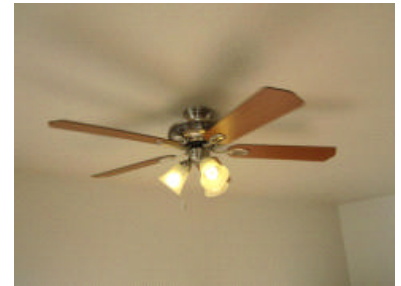
***Kitchen Interior:*** Satisfactory - There is a ceiling fan installed in this room. It appears to be functional.

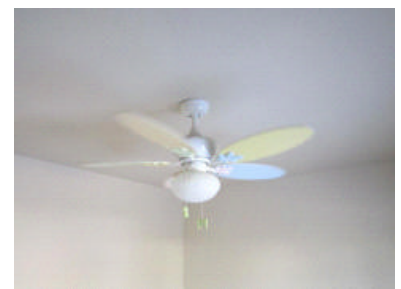
***Master Bedroom:*** Satisfactory - There is a ceiling fan installed in this room. It appears to be functional.

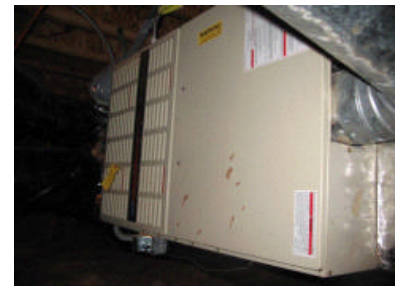
**Type & Location:** Forced Air, Basement.

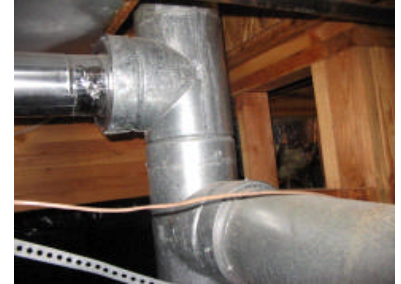
The flue pipe is metal.

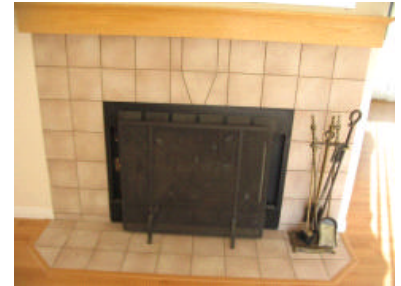
Wood - The fireplace is designed to burn wood. This unit appears to be designed for smaller esthetic fires and not used as a major heat source.

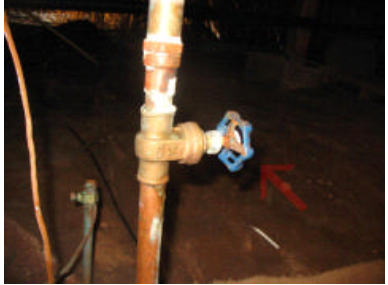
**Shut Off:** Main shutoff in the crawl space is located. Valve does not appear to be operational. I would have this looked at by a plumber and inquire with the seller or water company as to the location of any shut off on the exterior of the home.

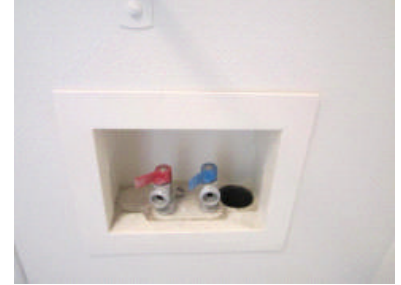
p " " There is a connection box installed in the wall with both hot and cold water and a drain pipe. The drain pipe was not flood tested.

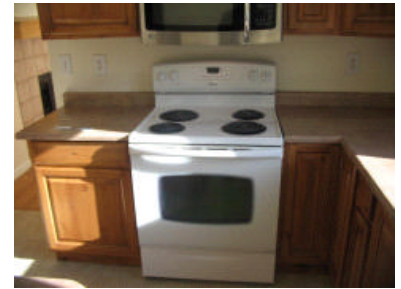
p " " Electric.

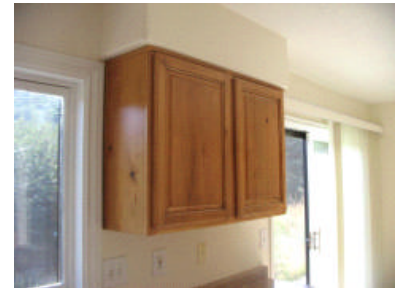
**Counters & Cabinets:** p " " Counters are Formica (plastic laminate) Cabinets are wood and they both appear to be in newer condition.

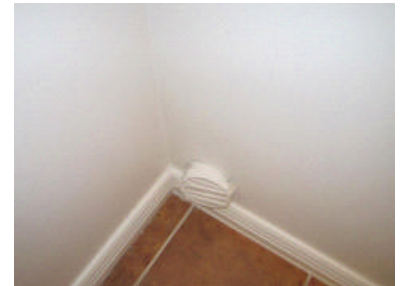
A dryer vent is provided,
